Lessons from the collapse during construction of an inlet pumping station : Geotechnical instrumentation aspects

Lessons from the collapse during construction of an inlet pumping station : Geotechnical instrumentation aspect

ABSTRACT: In the wastewater treatment plant, an Inlet Pumping Station (IPS) is one of the most important structures to collect and pump all wastewater to the treatment plant. The IPS presented in this paper consists of 20m deep underground chambers. A reinforced concrete diaphragm wall system 1.0m thick and 25m. deep was used in construction of the IPS. Four Inclinometer tubes were installed in the diaphragm wall to monitor the lateral wall movements during excavation work for basement construction. When excavation approached the final depth, excessive lateral wall movements were observed, but they were not taken seriously. Later, some cracks on the capping beam and noise from the bracing system were noticed. Then the IPS collapsed and was buried under sliding soil mass. At the time IPS collapsed five main bracing layers and only two of the five intermediate bracing layers had been installed. This paper emphasizes the importance of instrumentation. Additional

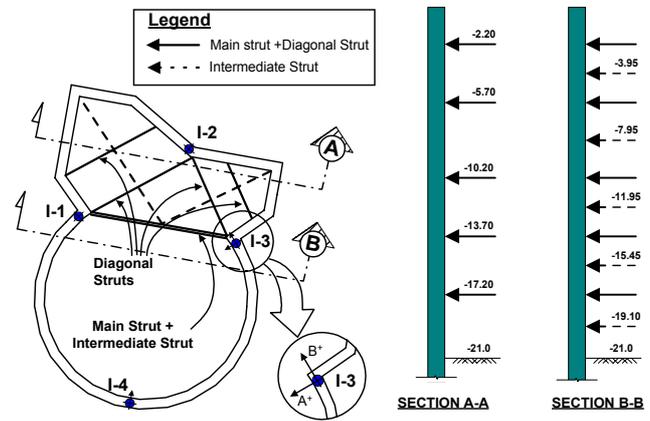
Figure 2. Temporary bracing system (Initial design)

For excavation work, five levels of temporary steel bracing were designed to support the straight wall portion and an additional five intermediate bracing layers was planned to frame the edges where the straight wall meets the circular enclosure (Fig. 2). Four inclinometer tubes were installed at critical points of the diaphragm wall to observe lateral movements during excavation for underground construction.

The bracing system was classified as temporary and thus no submission was made for review. The final temporary bracing arrangement (Fig. 3) was changed from the initial design in Figure 2. In the initial design, two lacing beams shown as a dashed line in Figure 2 were planned to strengthen the strutting system. However these were cancelled in the final temporary bracing system (Fig. 3).

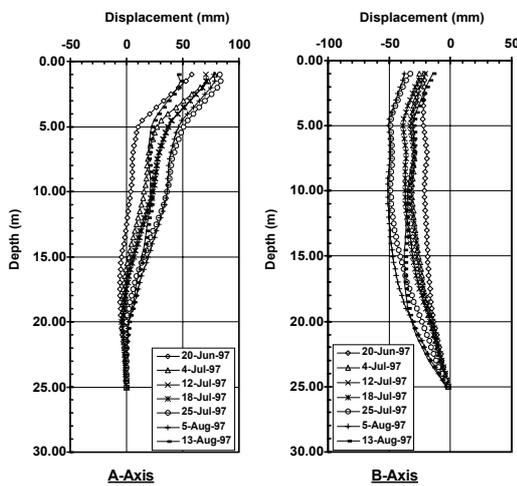
Figure 4a. Inclinometer reading of I-3

Lateral wall movements were recorded by I-3, located at one edge of circular enclosure and I-4, located in the intact zone (Fig.2). Wall movements in A-axis direction of the inclinometer access tube I-3 were indicative of the wall in cantilever/unsupported condition while those in B-axis direction were indicative of the wall being supported (Fig. 4a).

However, the wall movements in A-axis direction were considerably large and thus the main beams supporting the edges of the circular enclosure seemed not effective. The two differential move-

ments indicated that the edges of the wall between the straight wall and the circular enclosure had been under torsional stress. It was reported that tension cracks on the capping beam were observed in late July 1997. I-4 recorded wall movements with a maximum of 13mm (Fig. 4b). Movements of the wall toe could not be measured due to lack of the inclinometer tube penetration into the soil below the wall toe level.

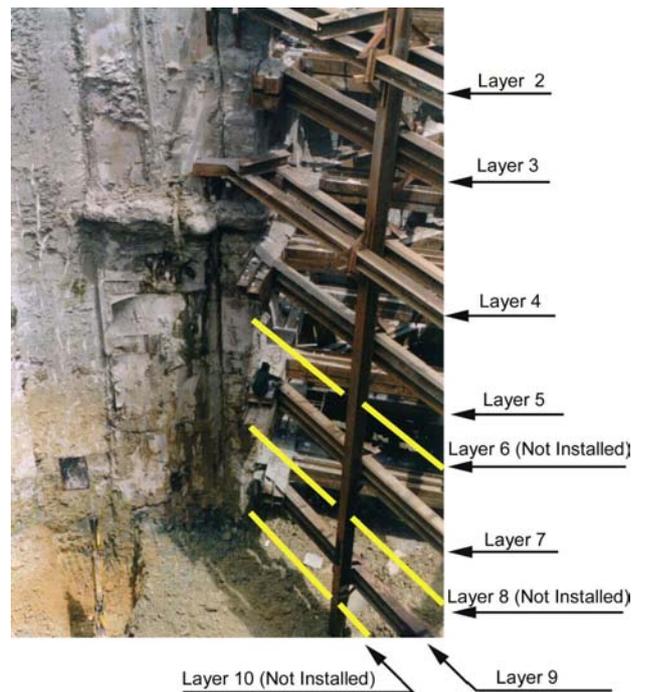
Figure 5. Bracing system seen on 16, Aug. 1997 (after Thasnanipan, 1997)

After observation of tension cracks on the capping beam, immediate installation of the remaining intermediate struts to support the edges of the circular enclosure and straight wall area were recommended. Occurrence of more cracks on the capping ring beam and noise from the bracing system was noticed. At this stage excavation depth inside the circular enclosure had been reached the final depth. However, only two of the five intermediate bracing layers had been installed at the time the IPS collapsed. Figure. 5 shows the photo of the bracing system taken one day before collapse. The IPS collapsed in the morning on 17 August 1997.

Figure 8 shows separations of the built-up walling beams and struts, which would reduce the capacity of the monolithic section by 30%. The three lower intermediate struts required at the edges of the circular enclosure were not present even though the excavation works reached the final depth (Fig. 5). This improper bracing also contributed to the cracks observed on the capping beam. Additionally, lateral movements of the walls, shown by inclinometer

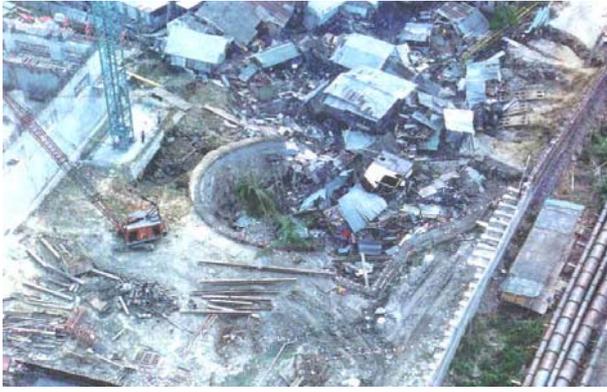
Figure 6a. After collapse soil mass moved in (after Thasnanipan, 1997)

After the collapse, soil mass caved in. Several adjacent wooden houses were also damaged and slipped down (Fig. 6a). The soil mass buried the collapsed portions of the wall, the steel bracing, and the excavation equipment (Fig. 6b). Some sections of the wall on the western side collapsed while the remaining wall sections stood in place. The collapse also sheared off the capping beam at the collapse location, causing severe cracking in the capping beam section, and opening panel joints on remaining sections of the wall. No human casualties were reported in the incident as the loud noise prior to the

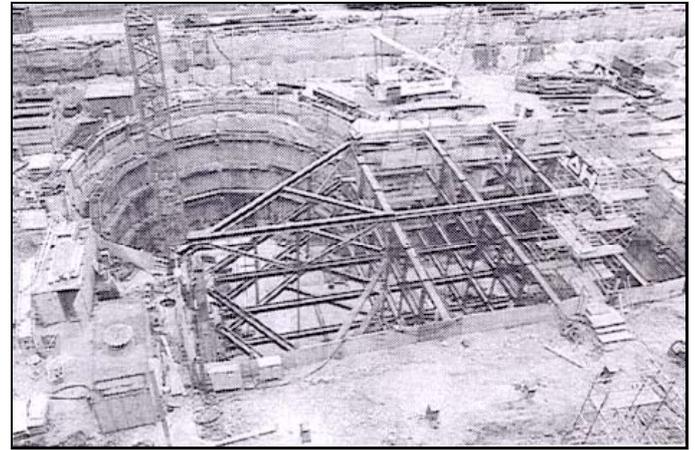
Figure 7. Underground construction of similar shape to IPS (after Katzenbach et al. 1998)

In the case of improper shape of the IPS, similar underground structure had been completed in Frankfurt, Germany (Katzenbach et al. 1998) as shown in Figure 7. Pit excavation was about 20.0m deep and a similar temporary strutting system was also used.

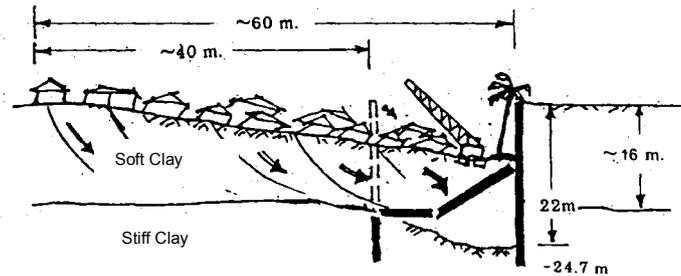
Figure 6b. Soil mass buried everything inside the pit. (after Phien-Wej et al. 1999)

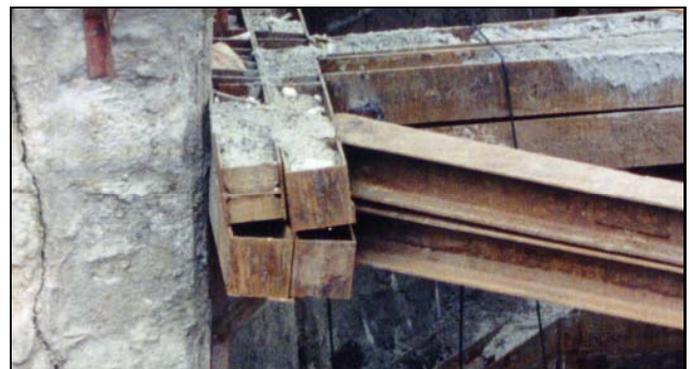
Figure 8. Separating of the built-up walling beams and struts in layer 3 (after Thasnanipan, 1997)

The importance of temporary bracing has been emphasized in various design guides, manuals and reports by Padfield & Mair (1984), William & Waite (1993) and Feld & Carper (1996). In the case of improper temporary bracing, this issue was identified as the main cause of collapse. Results of the analysis by means of FEM (Kanok-Nukulchai, et al. 1998) concluded that the main strut supporting the edges of the circular enclosure was grossly overstressed. The report also stated that these struts would have progressively reached their capacity at the initiation of the collapse and may have become totally ineffective. It was clearly indicated by the photographs taken just one day before the collapse of the IPS (Fig. 8).

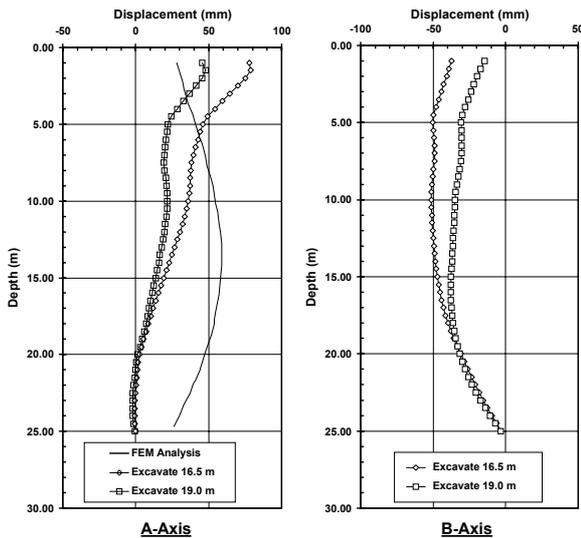
Figure 9. Prediction vs. actual wall behavior (I-3)

monitoring from I-3 indicated that the walls were in cantilever mode. The wall behavior did not reflect predicted behavior indicating inefficiency of the bracing system (Fig. 9). The cracks occurred in the capping beams confirmed cantilever wall movements.

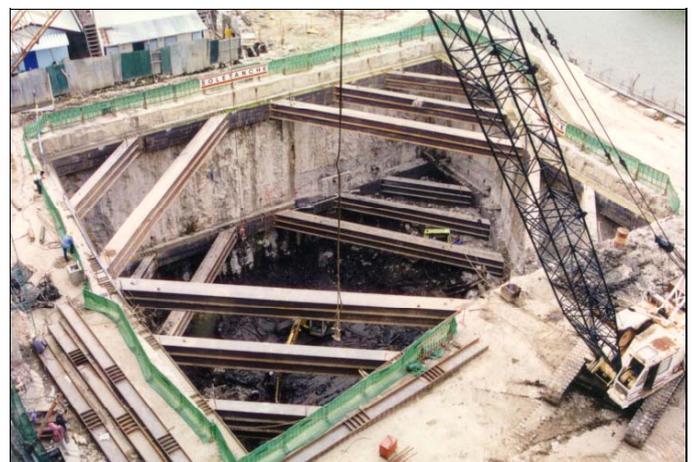
Figure 12. Excavation in progress for IPS reconstruction

Figure 12 shows the status of excavation and strutting before casting the new IPS structures inside the temporary diaphragm wall. The lateral wall movements were recorded by I-2 and I-6 with maximum wall deflections of about 50.0mm 70.0 mm respectively (Fig. 13). The reconstruction work was thus successfully completed with proper instrumentation.
