## **An International Conference on Geotechnical & Geological Engineering**

**Diaphragm wall and barrette construction for Thiam Ruam Mit  
Station Box, MRT Chaloem Ratchamongkhon Line, Bangkok**

**Thasnanipan N., Maung A.W. and Ganeshan B.**  
*SEAFCO Co., Ltd., Bangkok, Thailand*

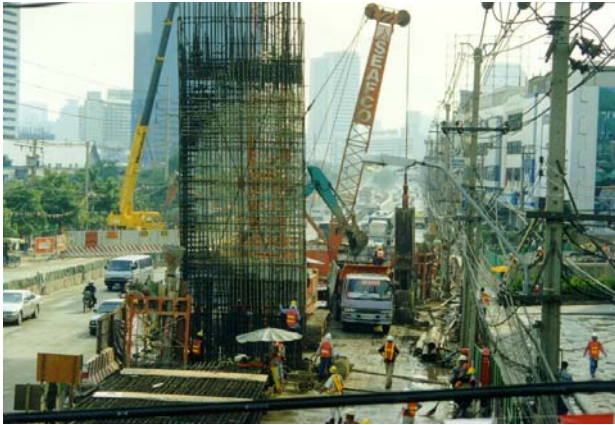
Figure 4. General view of the site

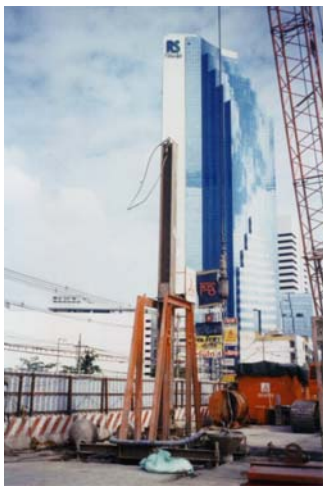
Figure 6. Guide frame for steel stanchion installation in barrettes

Conventional plunging method was not adopted in view of the site conditions, low cutoff level, the stanchion design and horizontal bar arrangements in the reinforcement cage. Two specially designed installation frames with adjustable screws were used for installation of stanchions to ensure high accuracy for verticality and plan position. A removable 10m-long, steel column was fixed on top of the stanchion to check the verticality and alignment.
