PROCEEDINGS OF THE SIXTH INTERNATIONAL CONFERENCE ON THE APPLICATION  
OF STRESS-WAVE THEORY TO PILES / SÃO PAULO / BRAZIL / 11 – 13 SEPTEMBER 2000

# Application of Stress-Wave Theory to Piles

# Sonic integrity test of piles-integrity effected by basement excavation in Bangkok Soft Clay

N. Thasnanipan, A. W. Maung, P. Tanseng & Z. Z. Aye  
*Seafco Company Limited, Bangkok, Thailand*

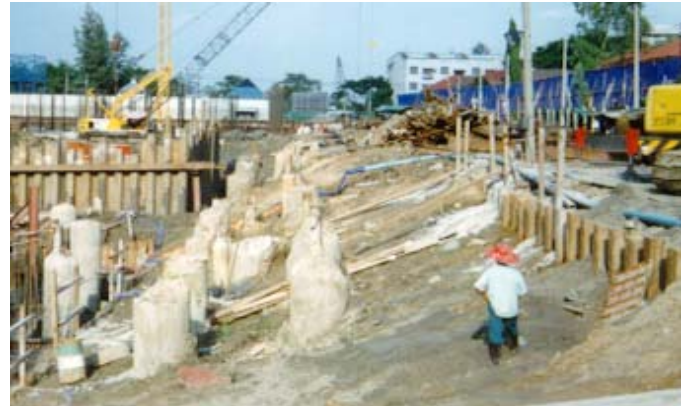
Figure 3. A picture showing slope excavation with sheet pile support – Case I

Excavation was initially carried out by using sheet pile (Type FSP III) with soil berm support or slope. Before reaching to -8.1m maximum depth of excavation, sheet pile failure and associate severe lateral

movement as well as settlement of ground including tension cracks of more than 300mm in width were observed at some locations. Minor damages were also investigated at the adjacent properties. Temporary raking struts were immediately installed in response to these excessive ground movements caused by sheet pile failure. A typical scheme showing excavation works of Case I is presented in Figure 3.
